2003 Annual Inspection Report for the Salt Lake City, Utah, UMTRCA Title I Processing Site

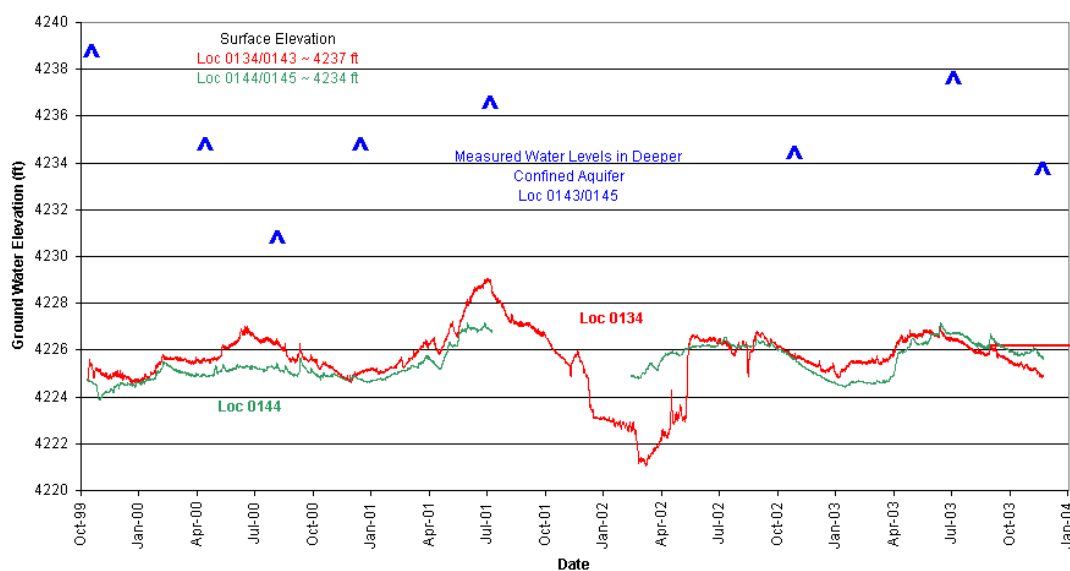
Figure 2. Ground Water Level Measurements at the Salt Lake City Processing Site

Water level dataloggers in the shallow wells were downloaded (continuous measurements) and the water levels were measured in the deep wells. In each well pair the water level was higher in the deep wells than in the shallow wells (Figure 2). This condition demonstrates the upward hydraulic gradient that prevents contaminated ground water from flowing from the contaminated shallow aquifer into the deeper aquifer.

Recommendation: Monitor ground water level data to verify that an upward hydraulic gradient exists between the lower and upper aquifers. Evaluate ground water level and quality data after the 2004 sampling event to develop a recommendation on whether or not to continue or modify ground water monitoring requirements.

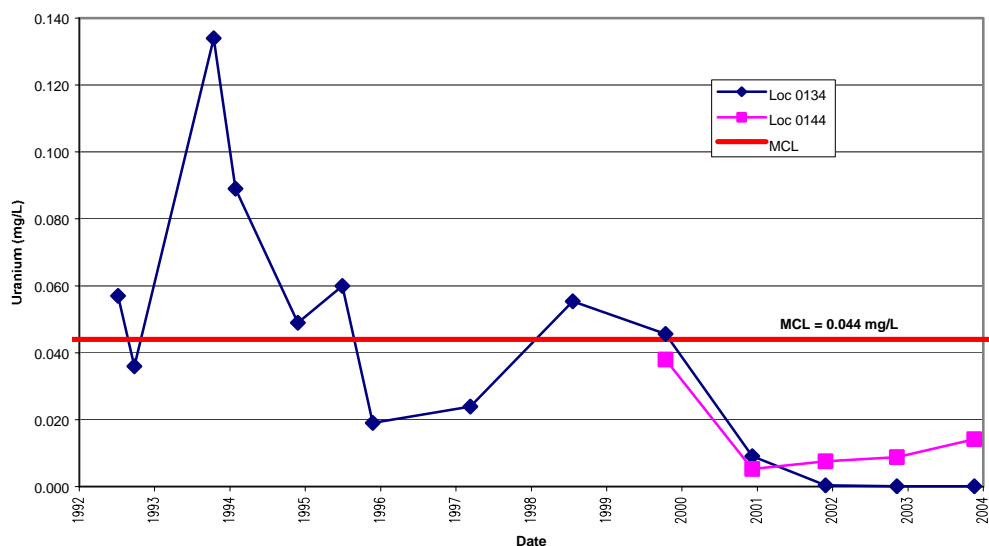
Figure 3. Shallow Aquifer Uranium Concentrations at the Salt Lake City Processing Site

Ground water samples were collected from the two shallow wells (MW-0134 and MW-0144). Uranium concentrations in both wells continue to be substantially below the MCL of 0.044 milligrams per liter (mg/L), as shown on Figure 3. The molybdenum concentration in MW-0134 continues to be well below the MCL of 0.10 mg/L; however, the concentration in MW-0144 has varied above and below the MCL, and was 0.215 mg/L this year (Figure 4). No trend for molybdenum in MW-0144 can be determined at this time.

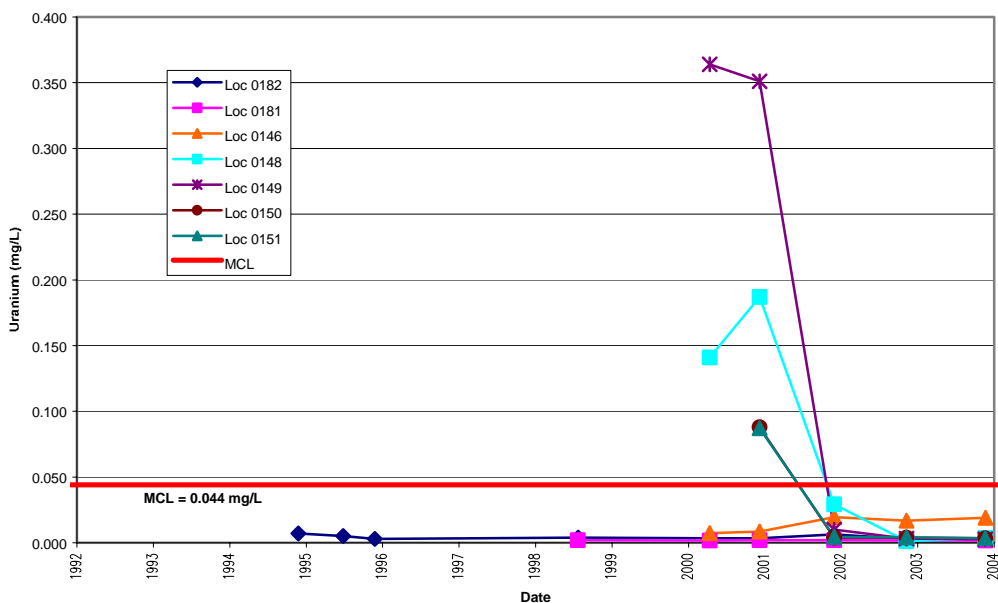
Figure 5. Surface Water Uranium Concentrations at the Salt Lake City Processing Site

Seven surface water samples were collected during the inspection (PL-3 through PL-9): four from the currently existing golf course ponds (SW-0148 through SW-0151); one from a golf drainage ditch (SW-0146); and two from Mill Creek—upstream (SW-0181) and downstream (SW-0182) of the CVWRF treated water discharge point. Uranium concentrations are below the MCL at all locations, with the highest concentration of 0.0183 mg/L at SW-0146 (Figure 5). Molybdenum concentrations also are below the MCL, with the highest concentration of 0.0460 mg/L at SW-0146 (Figure 6).

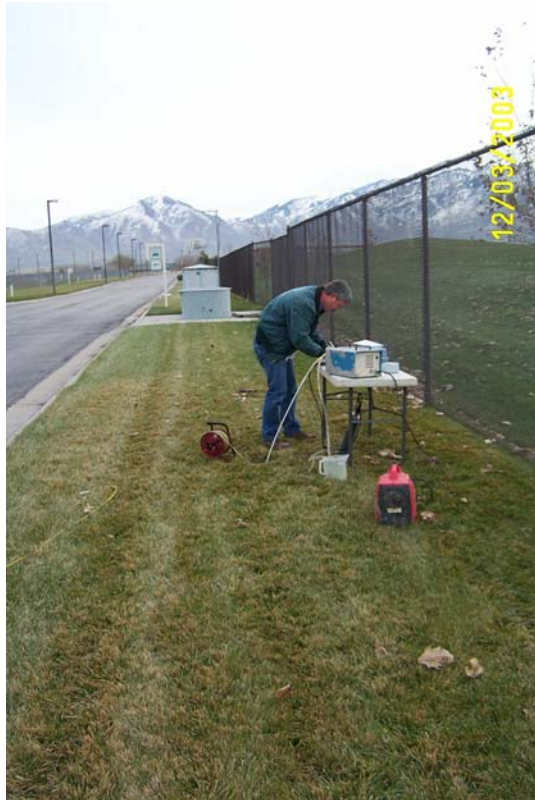
Four DOE-owned ground water monitor wells remain at the Salt Lake City Processing Site. The wells are located in pairs. In each pair, one well is completed in the shallow unconfined aquifer and the other is completed in the deeper confined aquifer. Two flush-mounted wells (MW-0144 and MW-0145) are located in a grass-covered area south of the Administration Building (PL-1). The other two wells (MW-0134 and MW-0143), located downgradient of the first pair, are in the northwest corner of the site (PL-2). All wells were secure and in good condition.

SLC 12/2003. PL-1. Sampling monitor well MW-0144 (MW-0145 is behind the sampler).

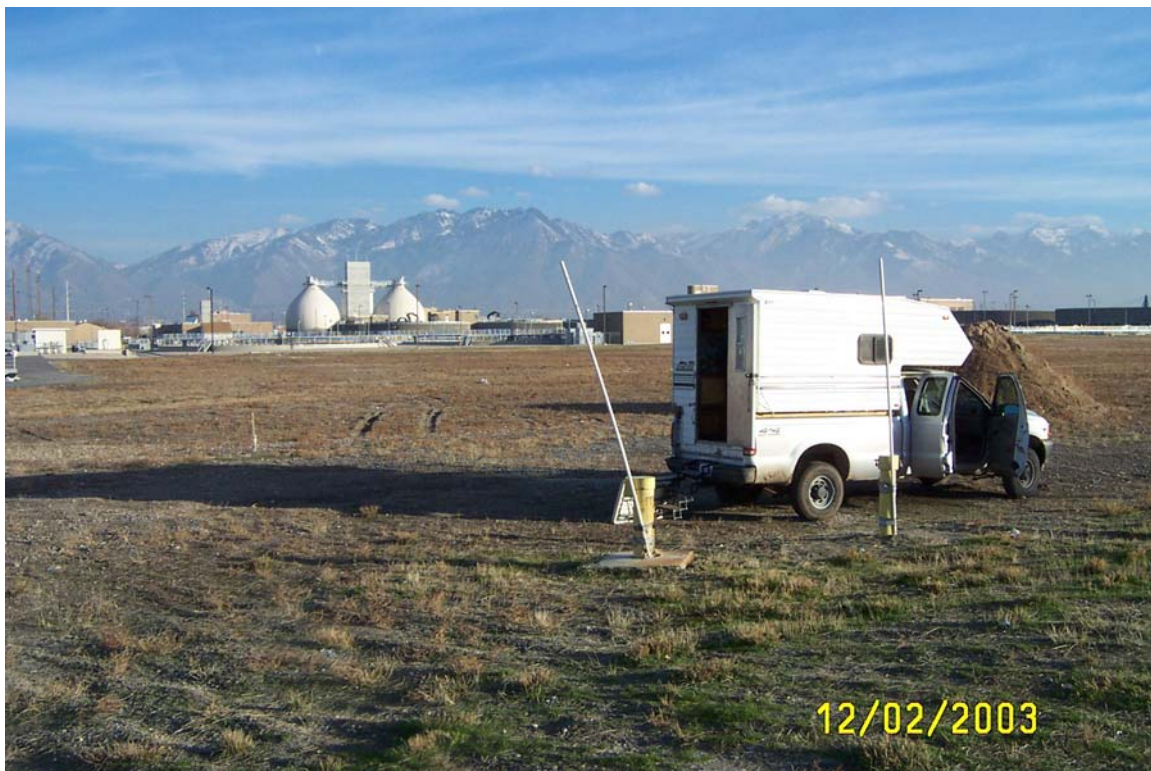
SLC 12/2003. PL-2. Monitor wells MW-0143 (left, deep aquifer) and MW-0134 (right, shallow aquifer).

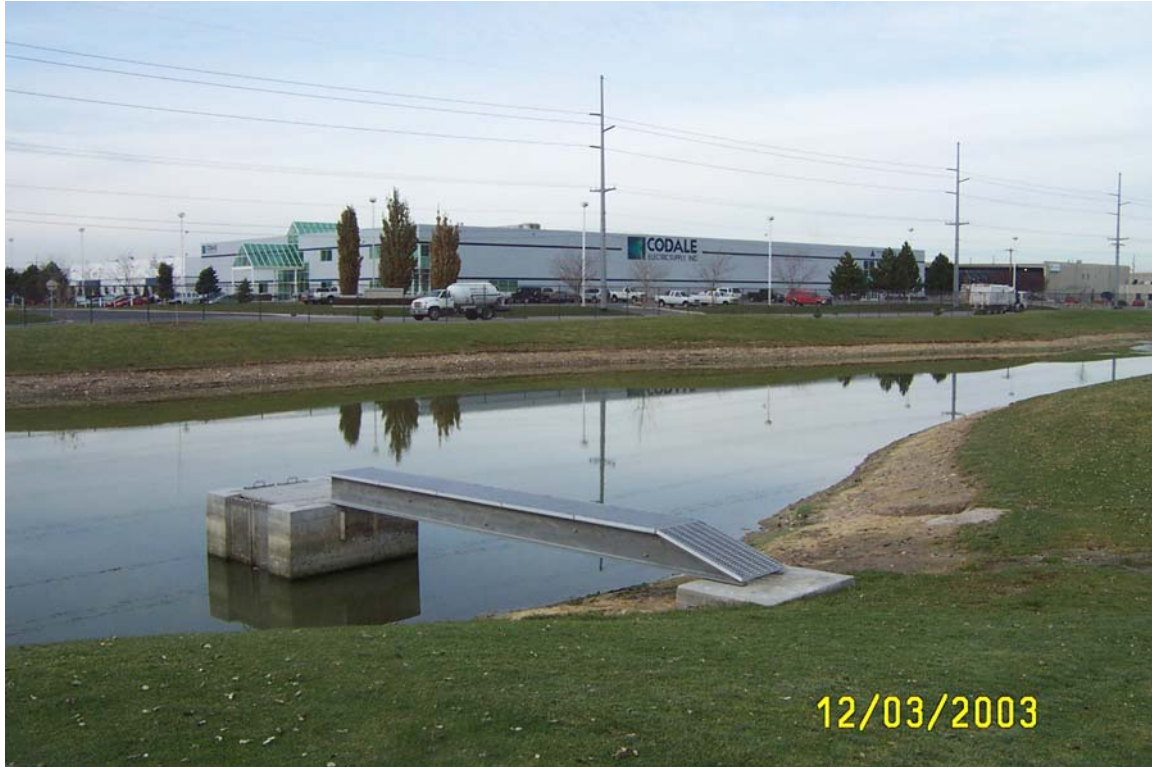
SLC 12/2003. PL-3. Golf course pond sampling location SW-0148.

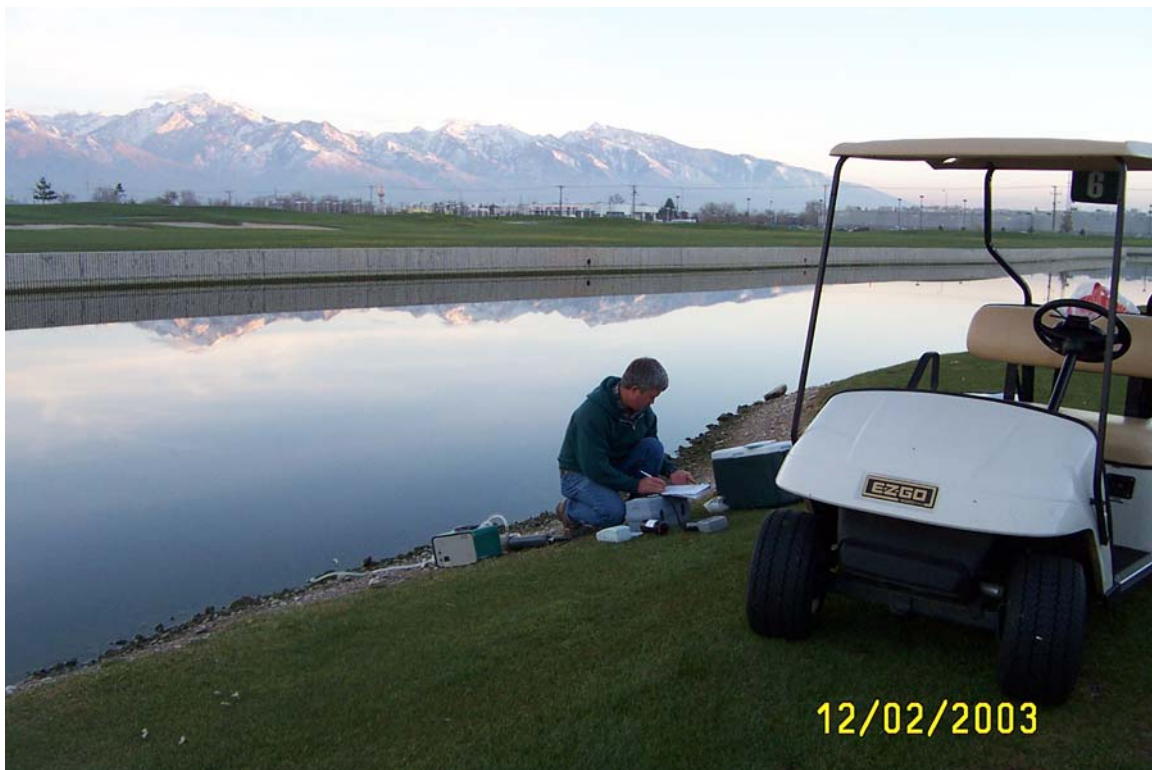
SLC 12/2003. PL-4. Golf course pond sampling location SW-0149.

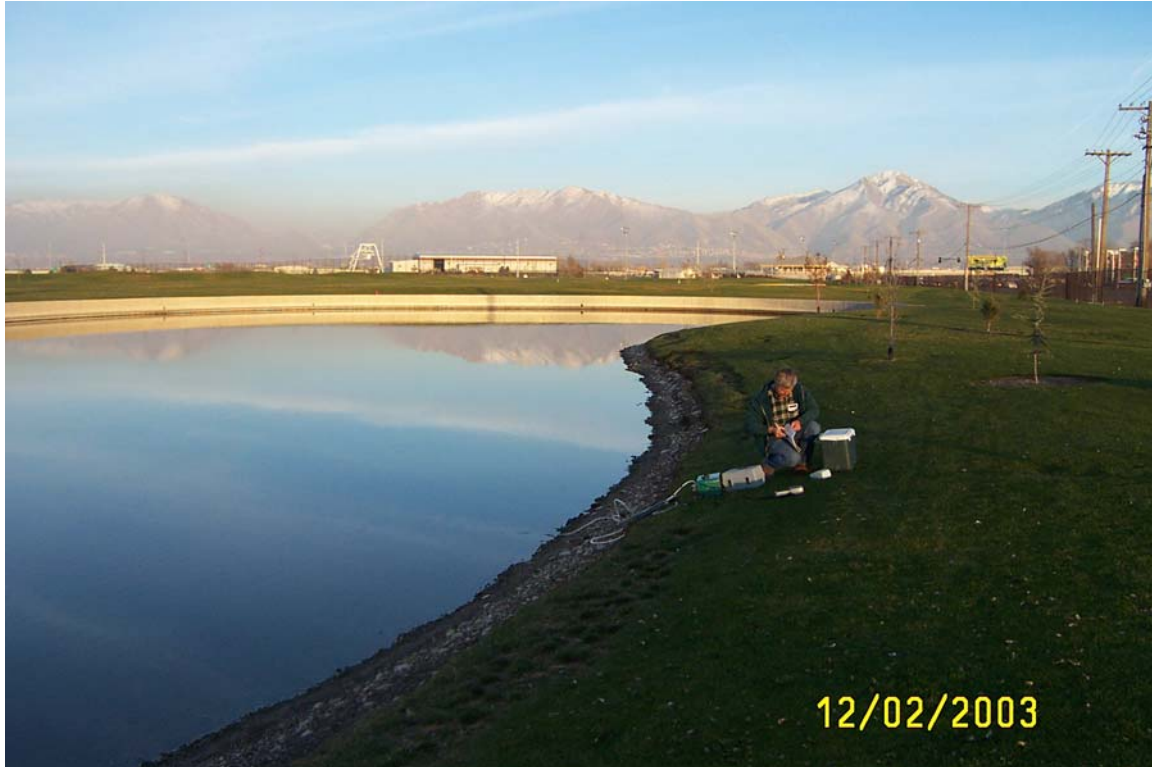
SLC 12/2003. PL-5. Golf course pond sampling location SW-0150.

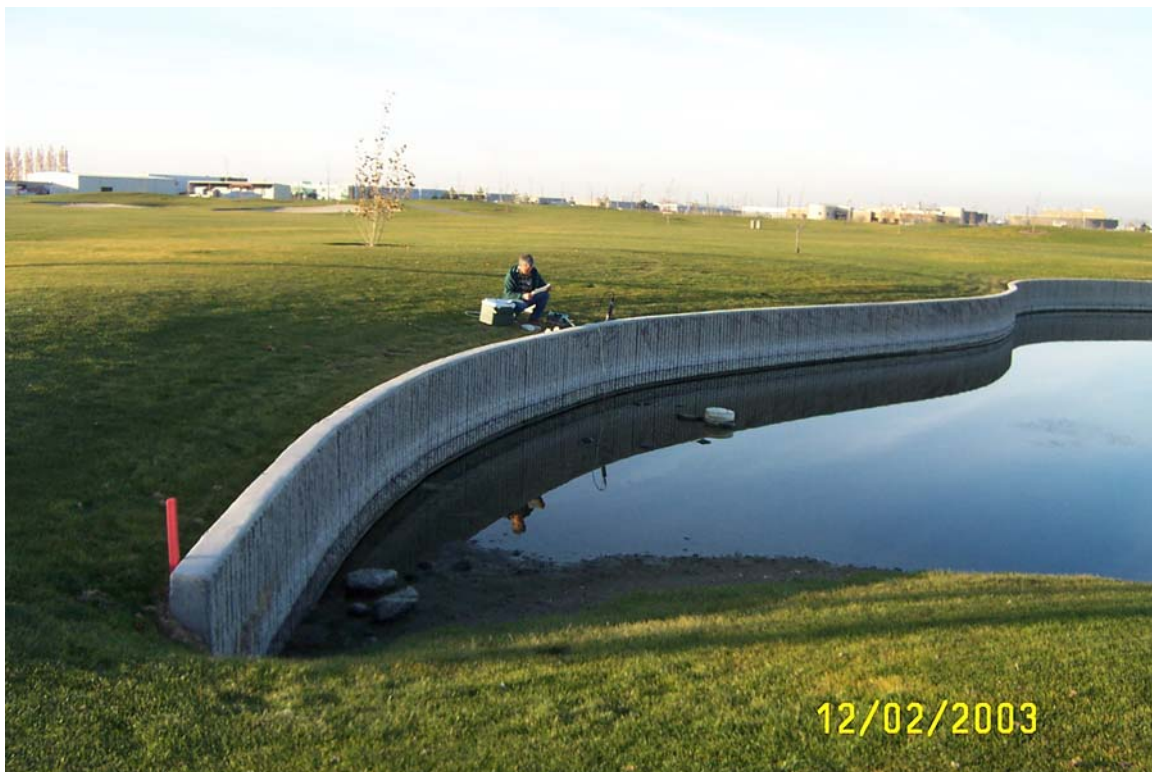
SLC 12/2003. PL-6. Golf course pond sampling location SW-0151.

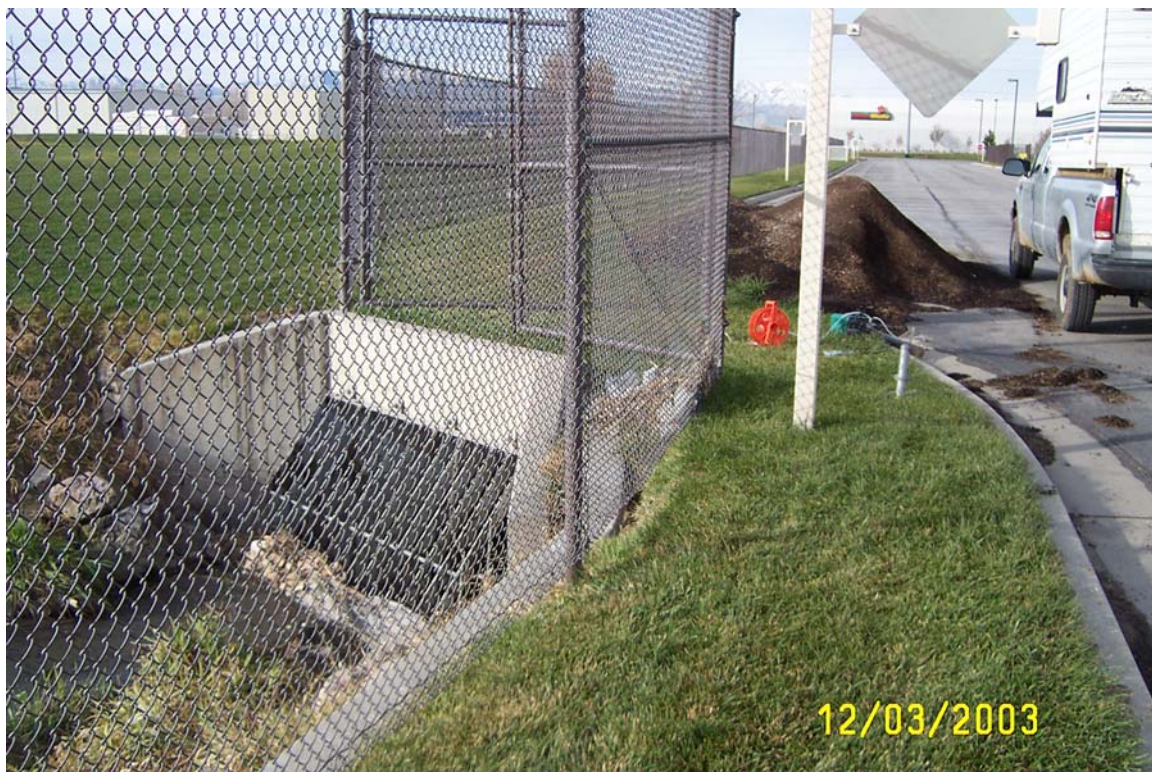
SLC 12/2003. PL-7. Golf course drainage ditch sampling location SW-0146.

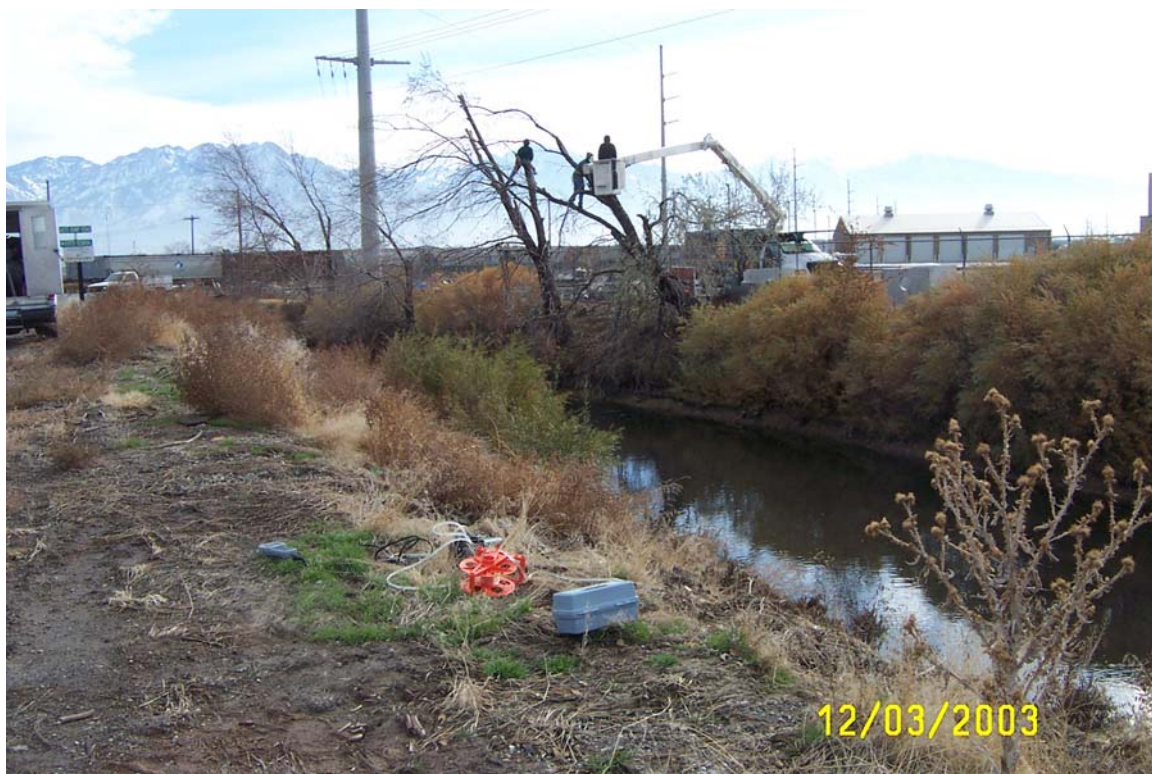
SCL 12/2003. PL-8. Mill Creek sampling location SW-0181, upstream of the treated water discharge point.

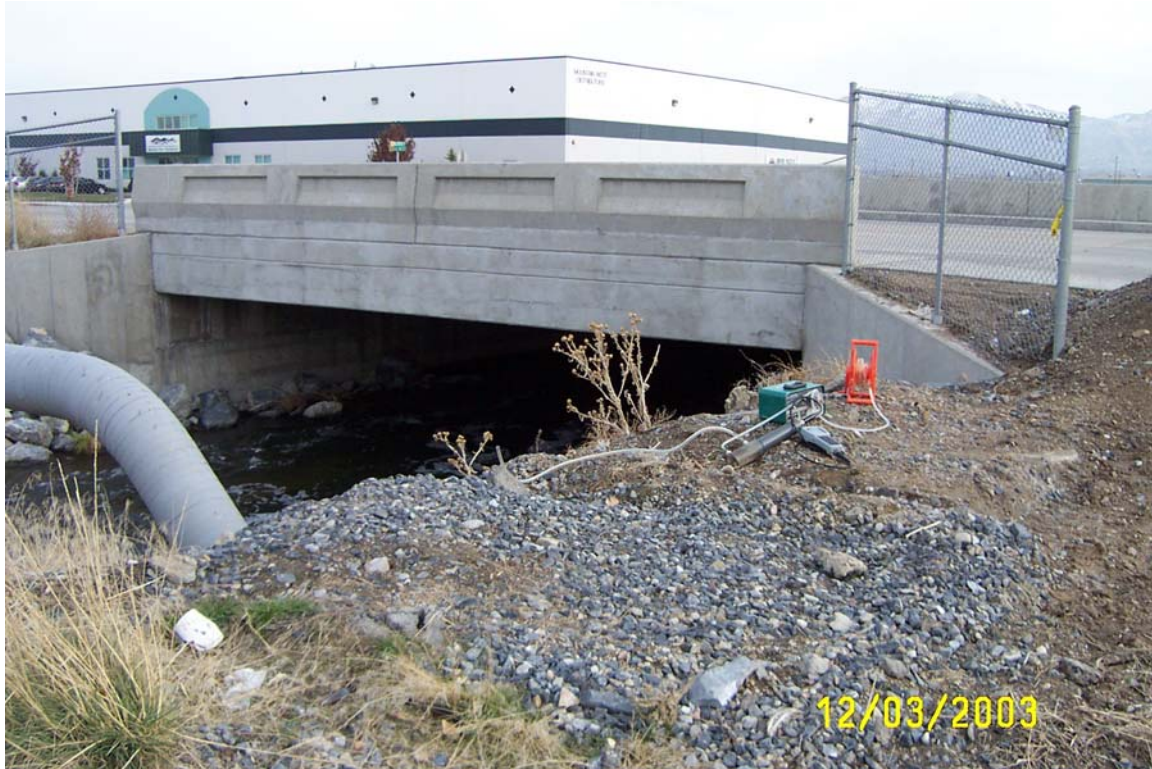
SLC 12/2003. PL-9. Mill Creek sampling location SW-0182, downstream of the treated water discharge point.
